EXHIBIT 2

Ref: Vacant Sears Store Roof Inspection

Site Inspection Report

Site: Cross County Shopping Center
Location: Sears Lower Level

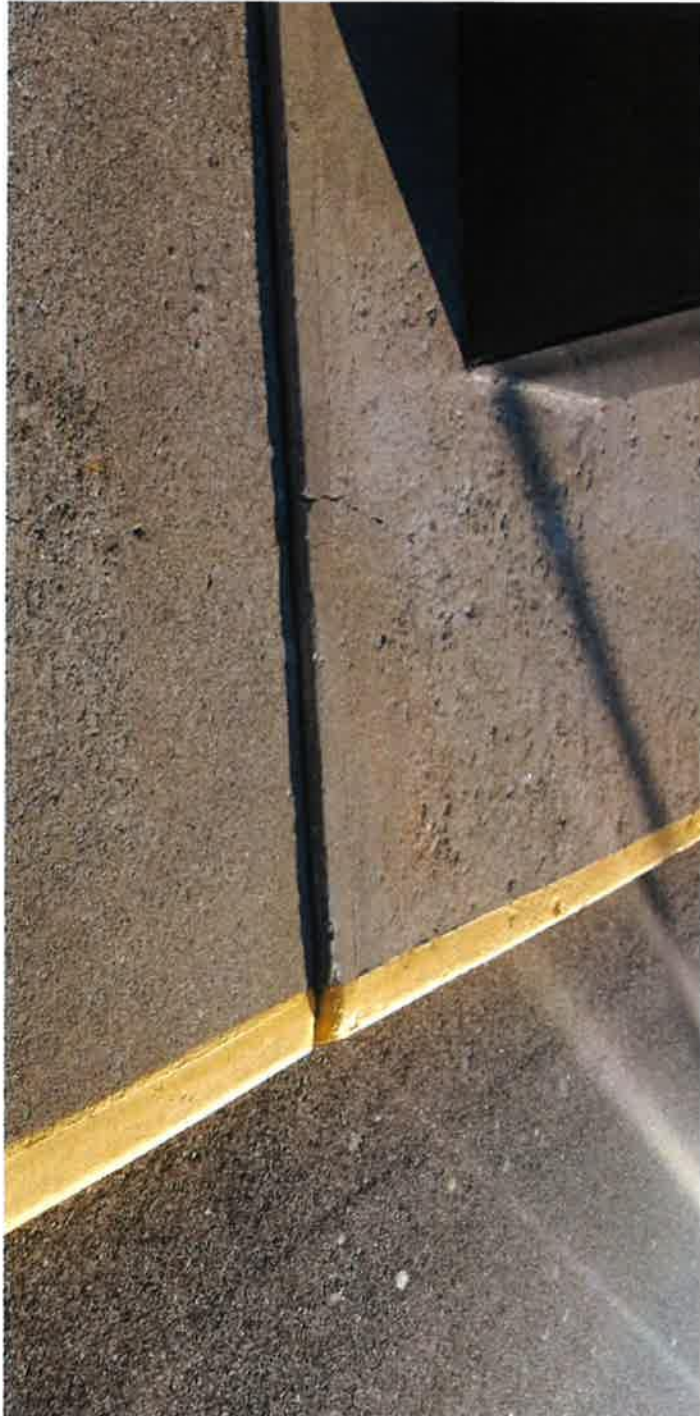
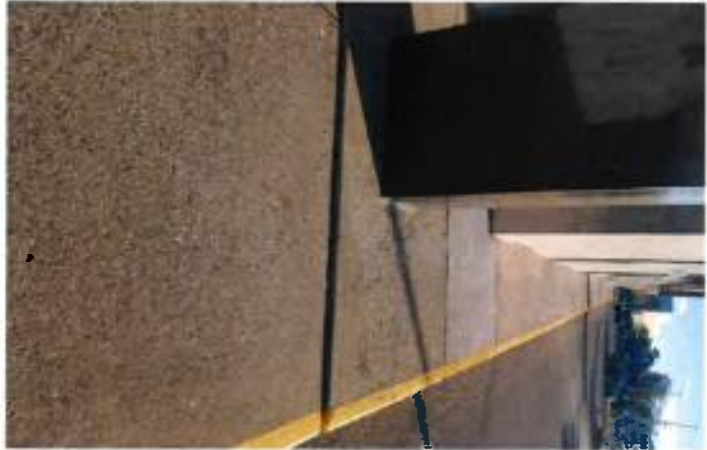
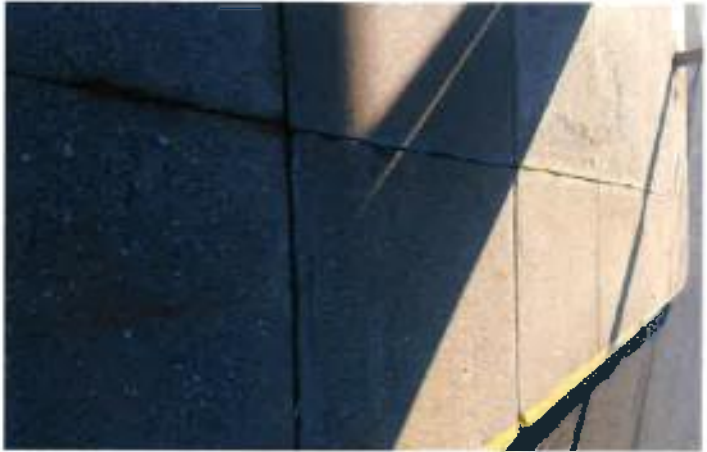
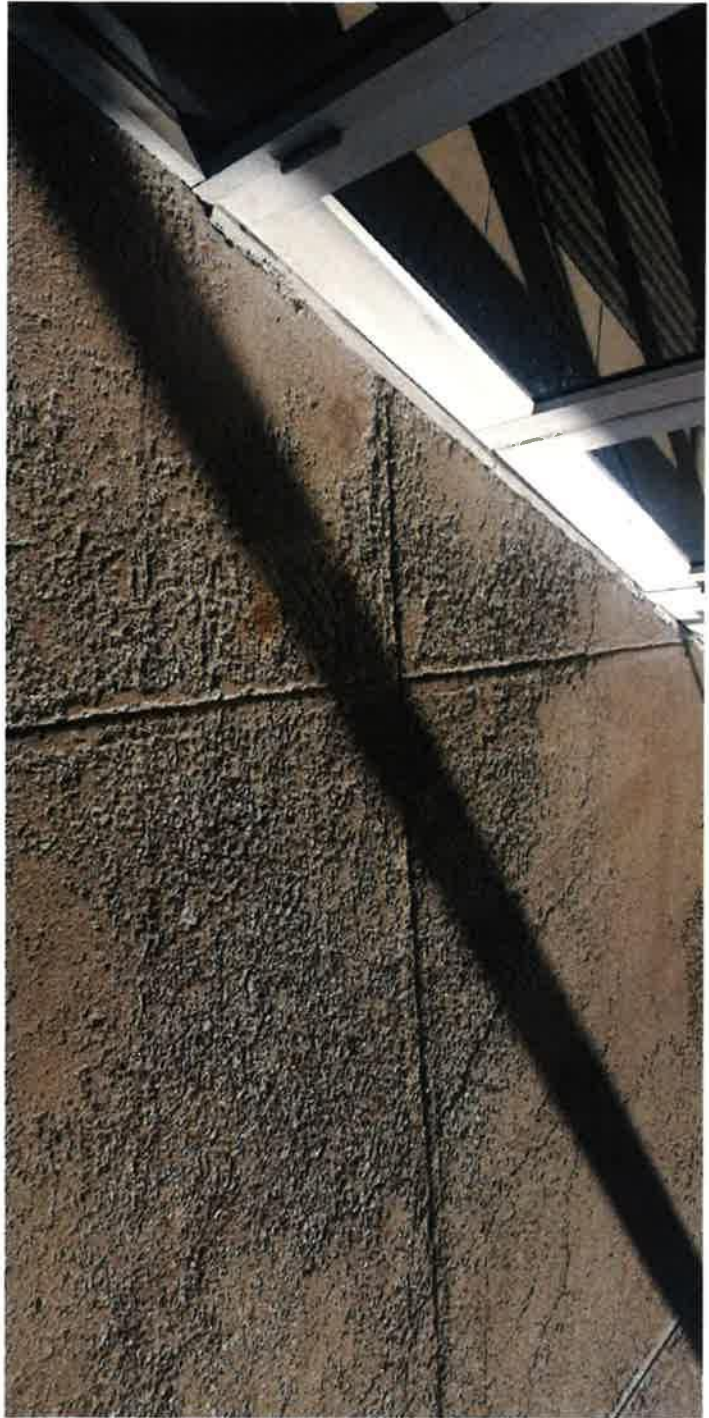
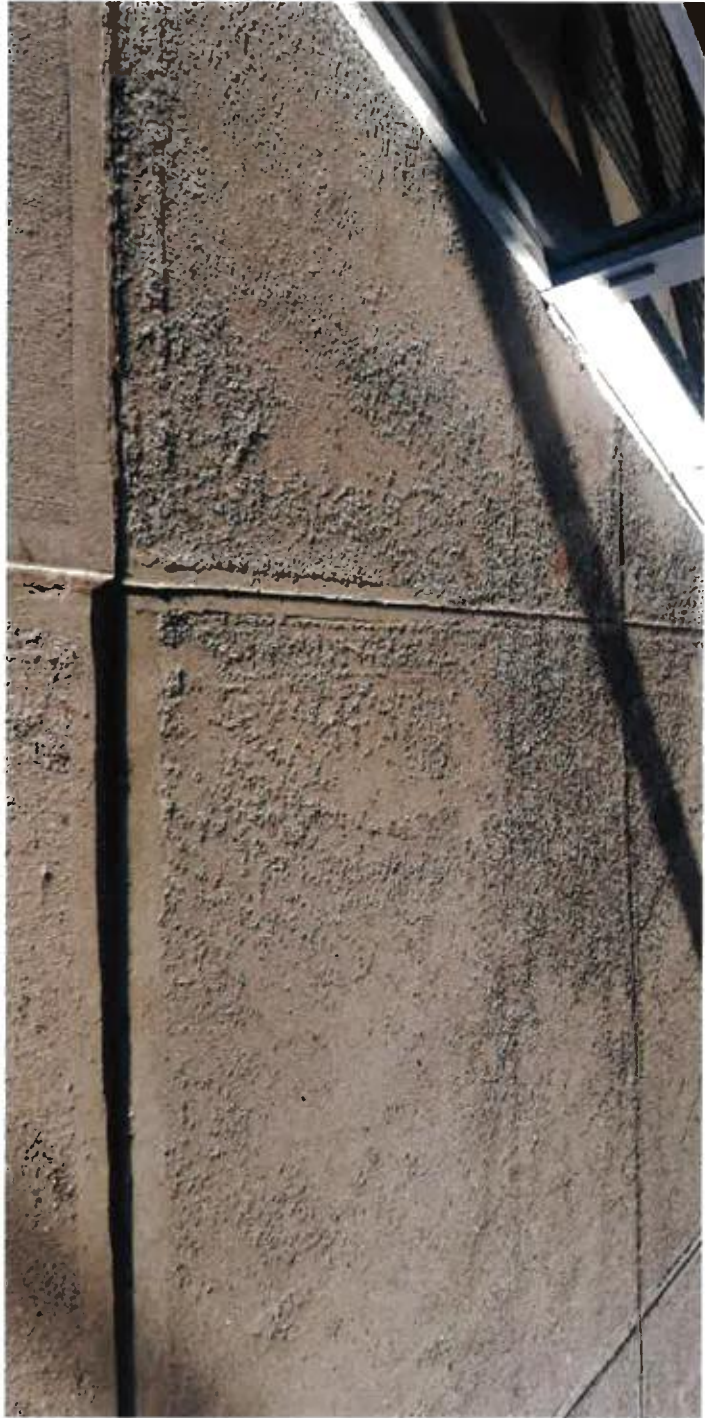
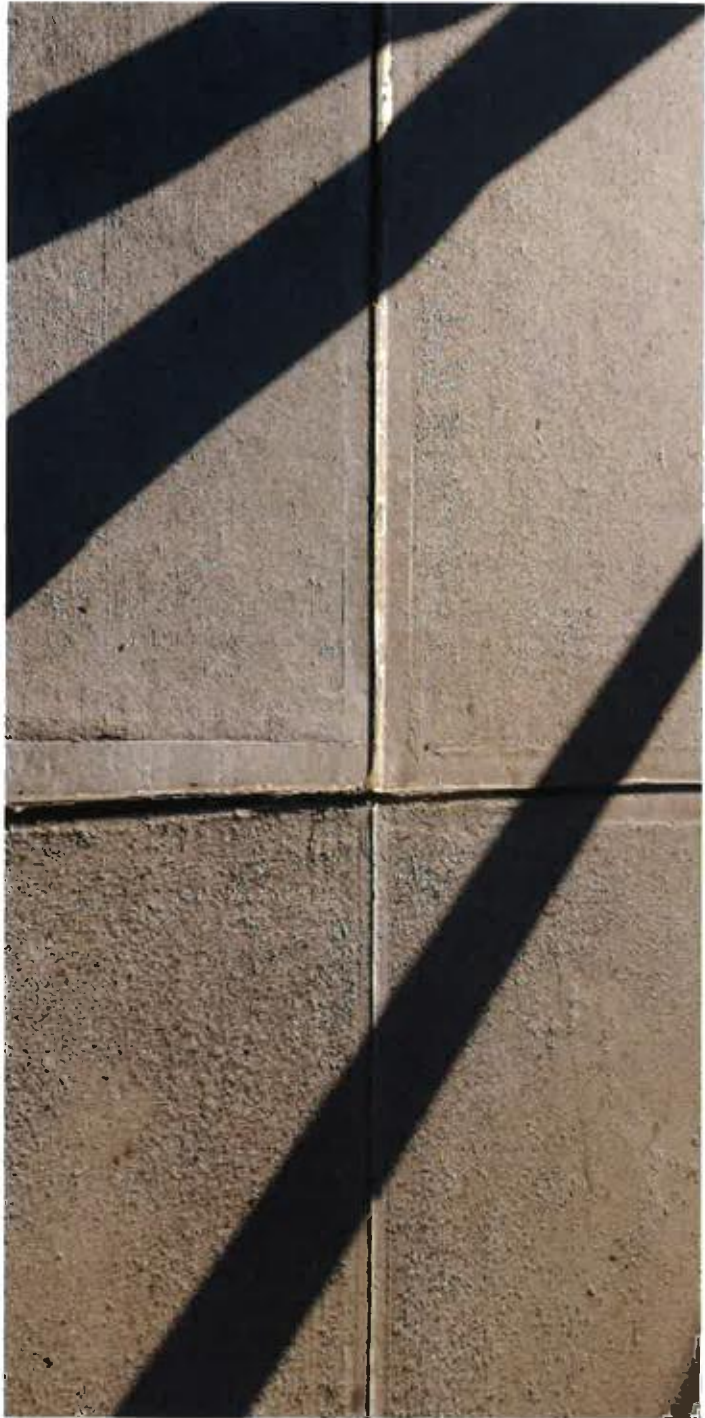
Side walk trip hazards
1. Missing
2. Trip
3. Trip hazards
4. Surface curbs

Inspector's Recommendations
1. Remove and replace sidewalk to comply with code
2. Remove and replace sidewalk to comply with code
3. Remove and replace sidewalk to comply with code
4. Remove and replace sidewalk to comply with code
Hazards should be addressed

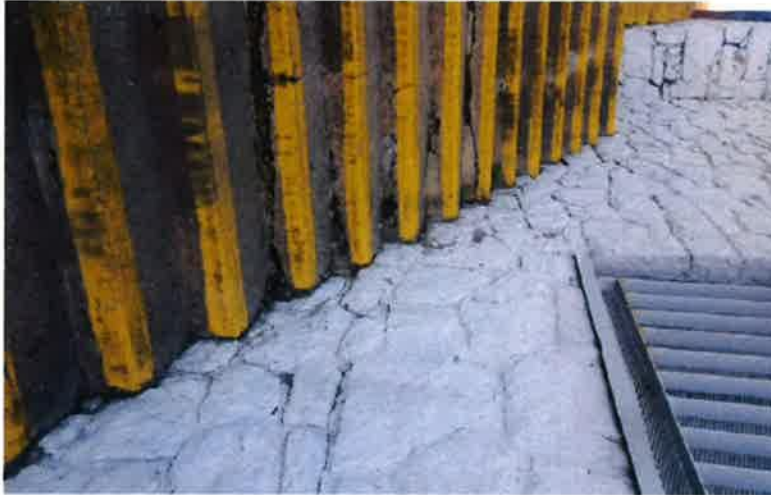
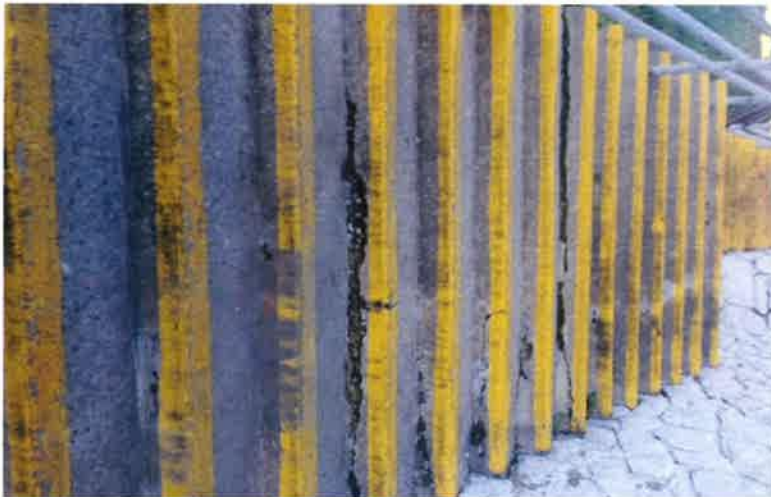
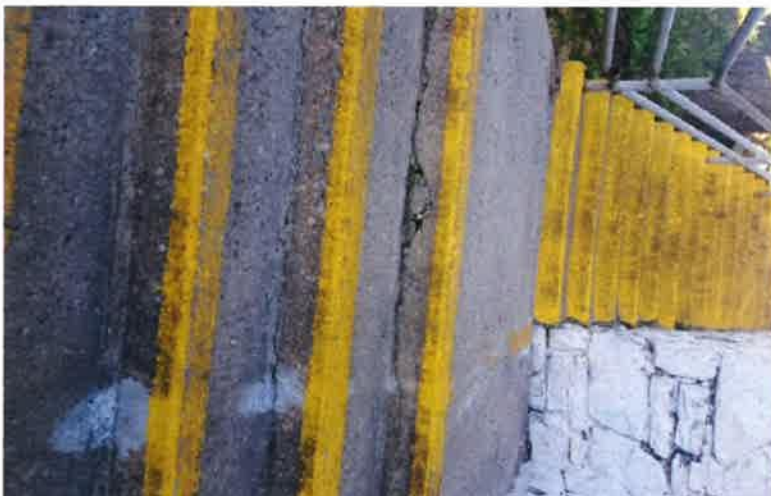
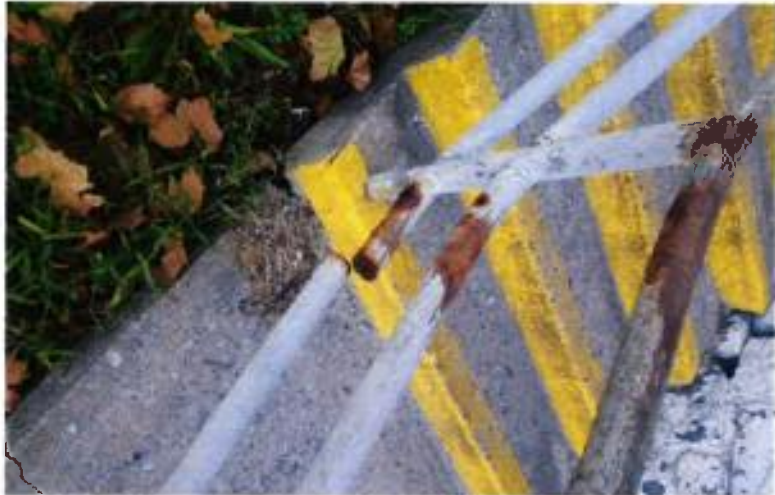
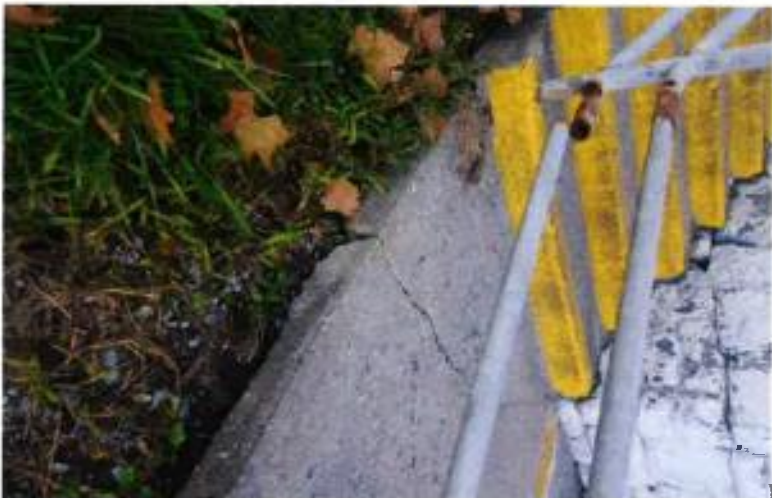
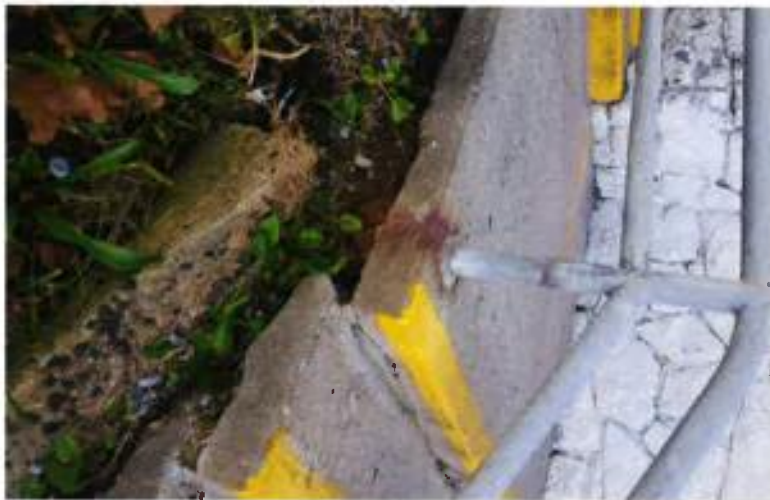
stairs in poor condition

1. Damaged Risers
2. Damaged treads
3. Damaged Railings
4. Improper riser height due to movement
5. Trip hazards

- Inspector's Recommendations:
1. Remove and Replace stairs with a uniform riser height
 2. Remove and Replace stairs with a uniform tread width
 3. Remove and Replace railing with a uniform railing height
 4. Remove and Replace stairs with a uniform riser height
 5. Remove and Replace stairs with a uniform riser height
- Hazards should be Addressed

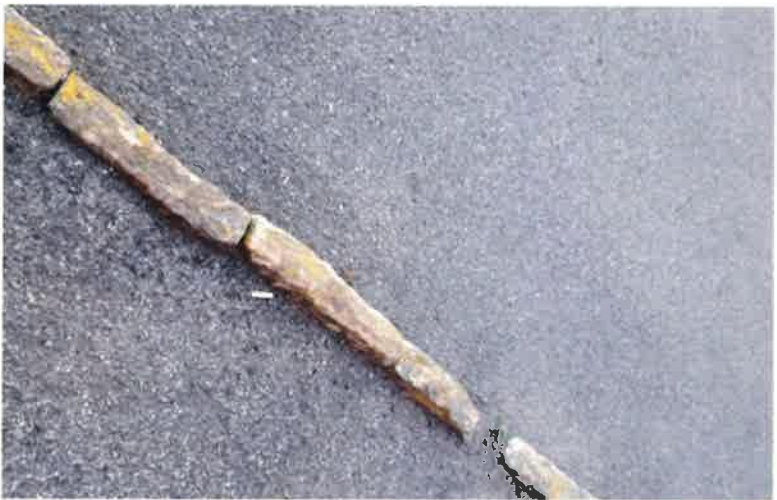
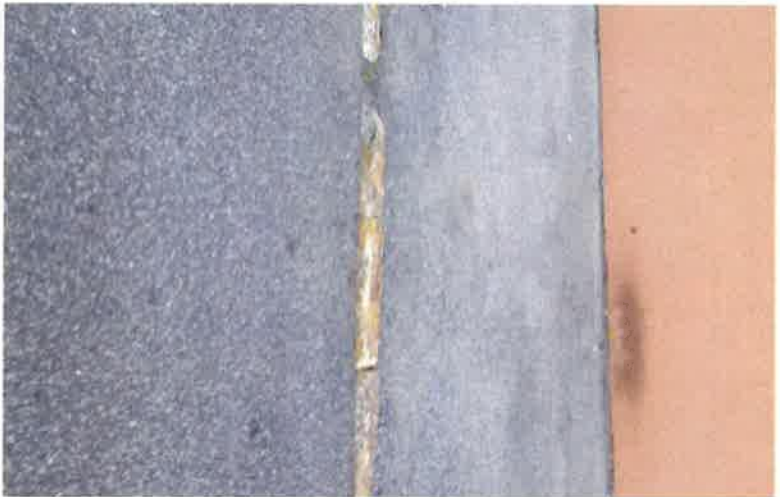
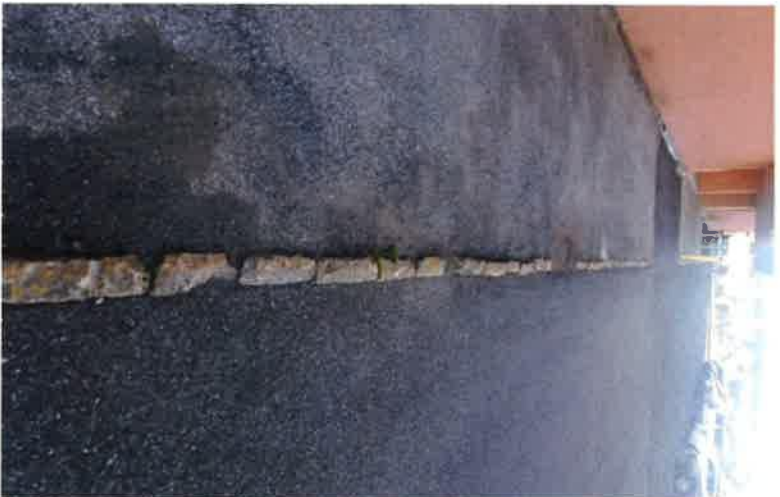
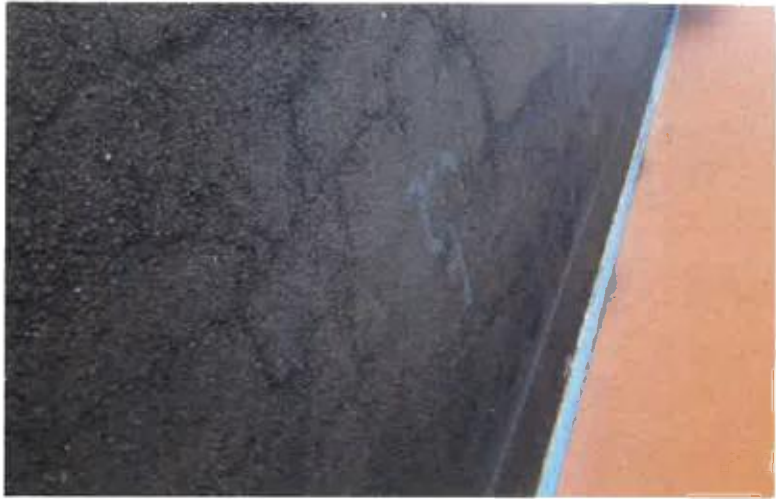
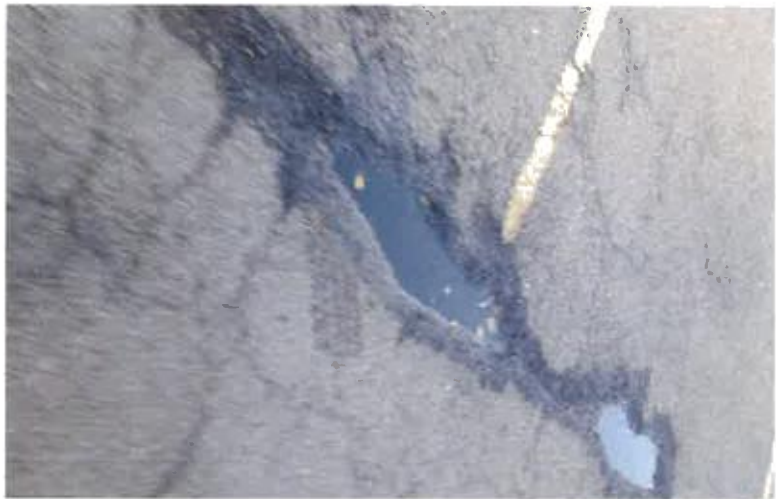
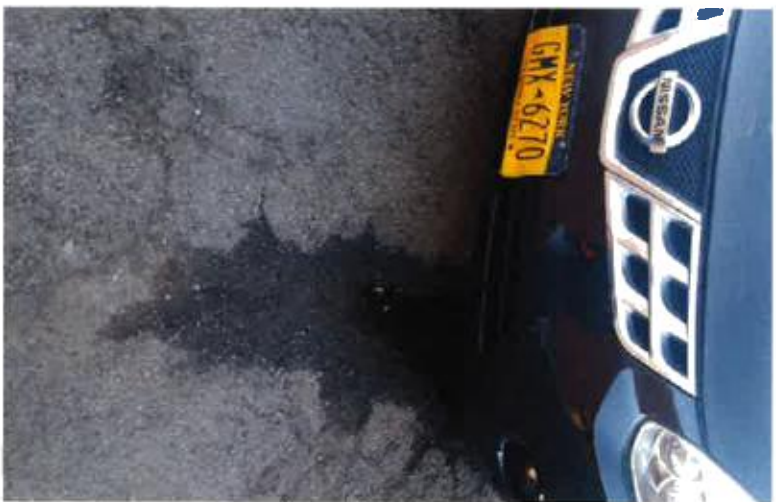
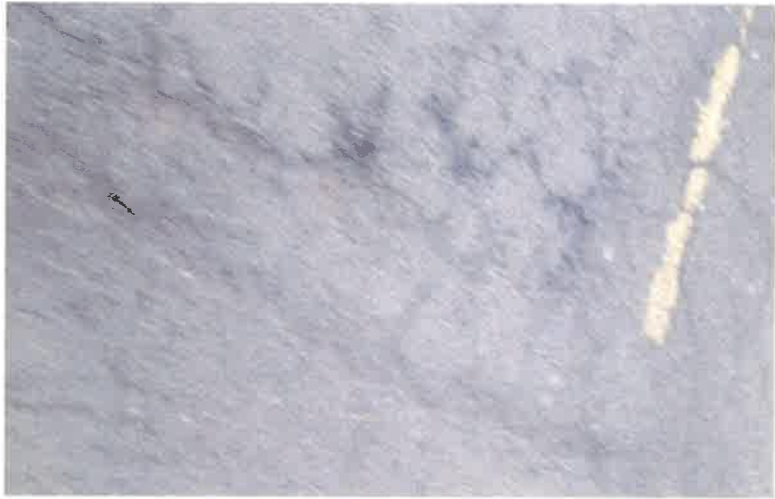
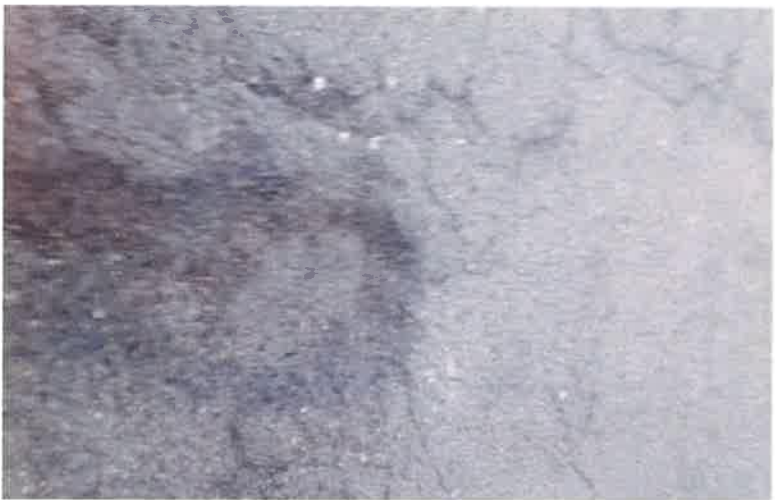
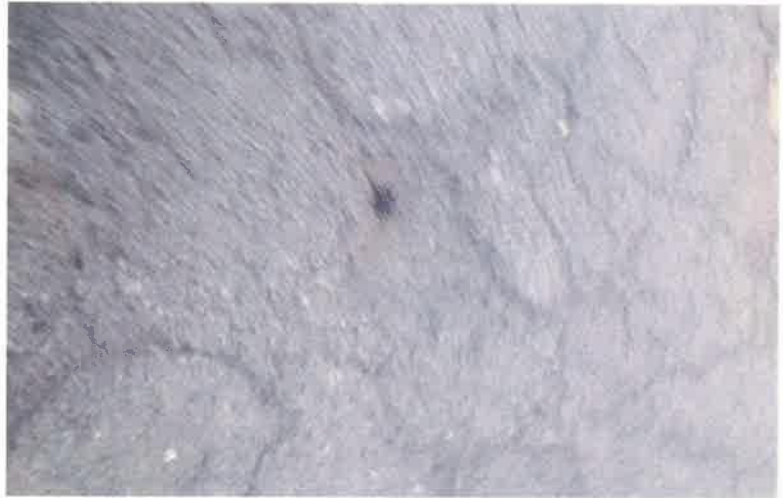
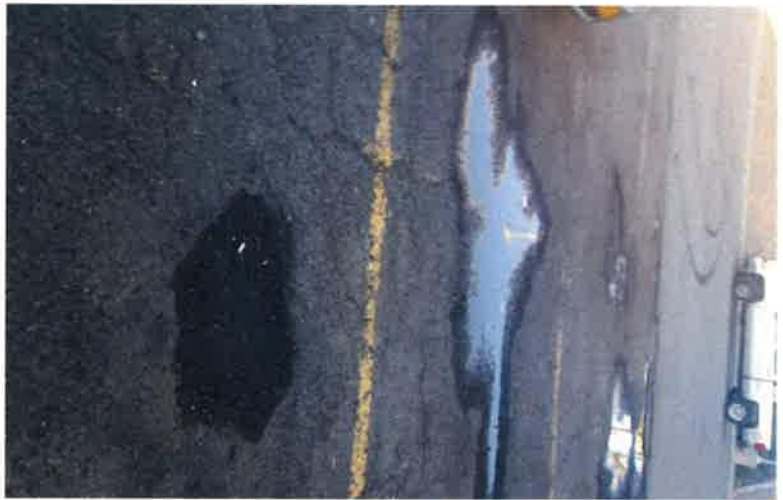
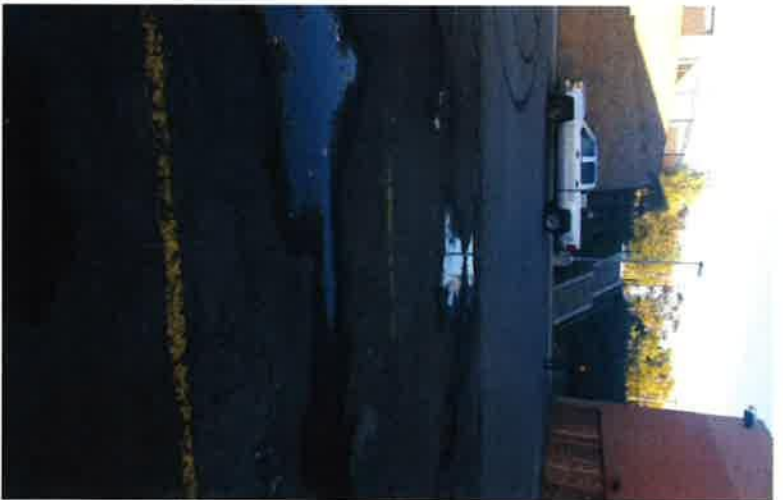
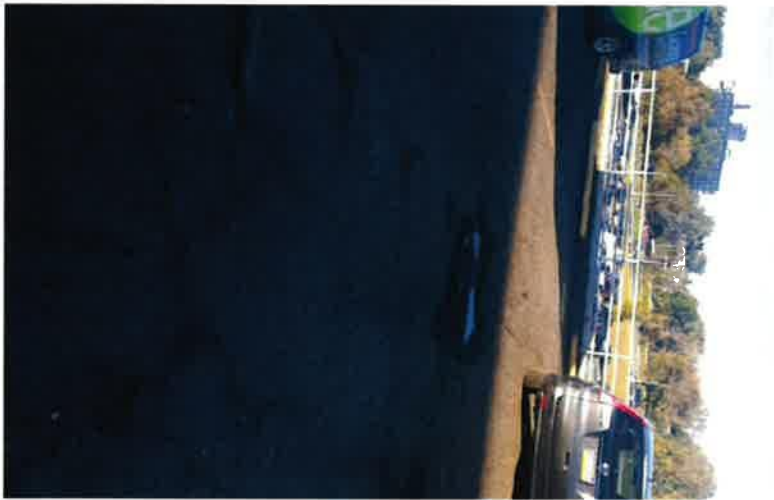
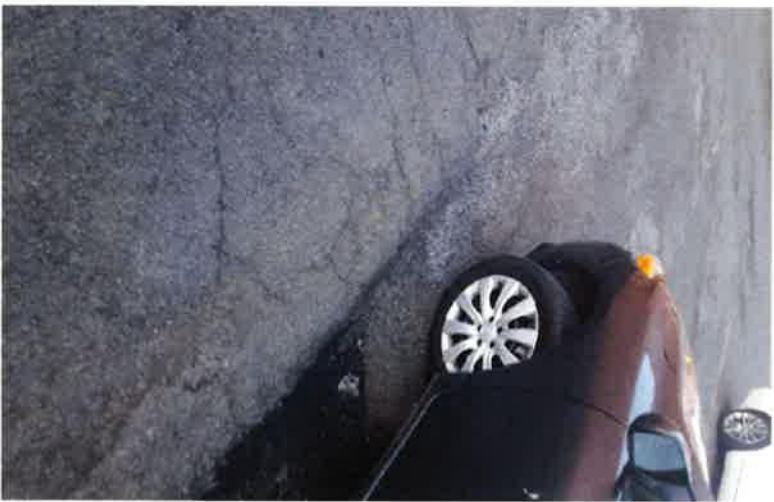
Side walk curb and black top side walk

- 1. Missing
- 2. Damaged
- 3. Trip hazard
- 4. Curbside

Parking Area

- 1. ADA parking Area Non-compliant
- 2. entire area in poor condition
- 3. not built with standing water possible leaving and causing structural damage
- 4. Multiple locations most of black top missing and possible waterpooling
- 5. Multiple locations black top is missing causing a trip hazard

- Inspector's Recommendations
- 1. Replace curb and sidewalk to comply with code
 - 2. Replace curb and sidewalk to comply with code
 - 3. Replace curb and sidewalk to comply with code
 - 4. Replace curb and sidewalk to comply with code

- 1. Install ADA marking and signs as per the latest ADA requirements
- 2. Consult structural engineer, water proofing consultant, for course of action
- 3. Consult structural engineer, water proofing consultant, for course of action
- 4. Consult structural engineer, water proofing consultant, for course of action
- 5. Consult structural engineer, water proofing consultant, for course of action
